PROPERTY INSPECTION REPORT

Bastian Home Inspection

Property Address: 1234 Oak Street

Date of Inspection: 11/20/2023

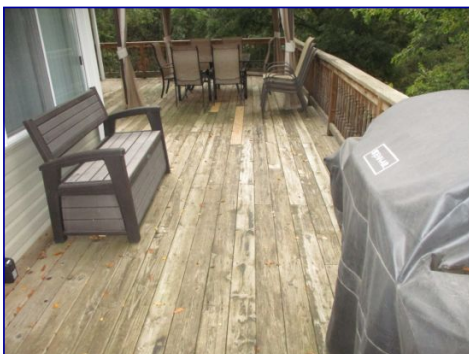
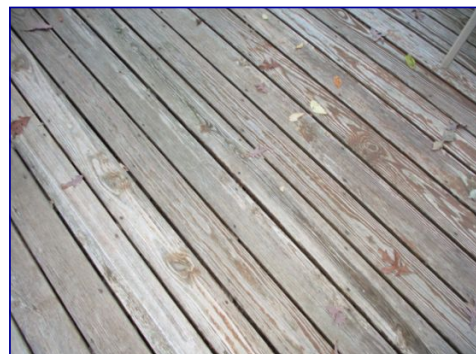
5. Deck/Balcony

- Materials:
- Wood
- Condition:
- Bare wood showing.
- Observations:
- The wood decking needs to be resealed. Recommend resealing the wood on the deck to help protect it from damage.

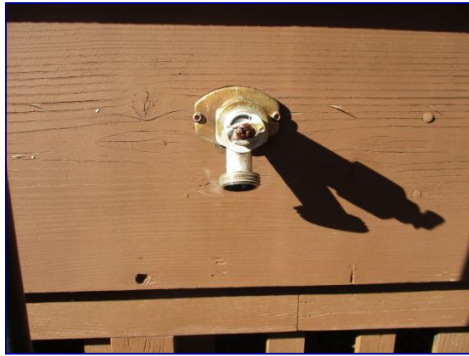
6. Hose Bibs

- No, not operable

- The front hose bib is damaged/not working properly. Repairs needed by a qualified plumbing contractor.

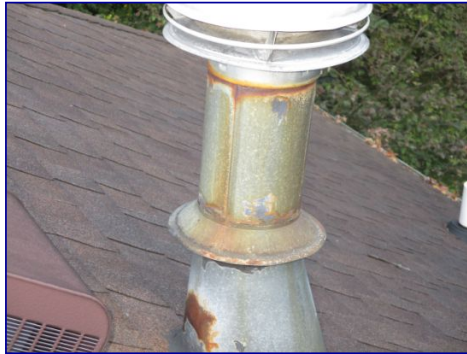
1. Chimney Chase

- Evidence of: Rust

- The chimney/vent pipe is rusting. I recommend painting/resealing the vent pipe to extend its life span. Further evaluation and repairs are recommended by a qualified contractor.

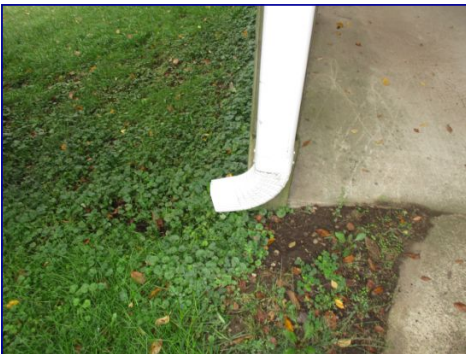
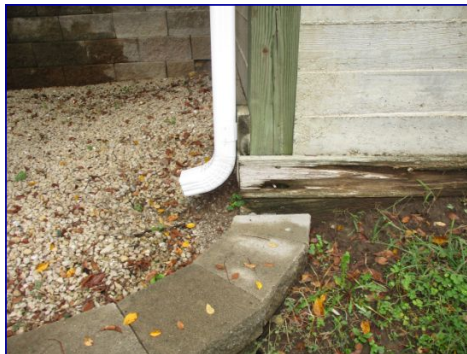
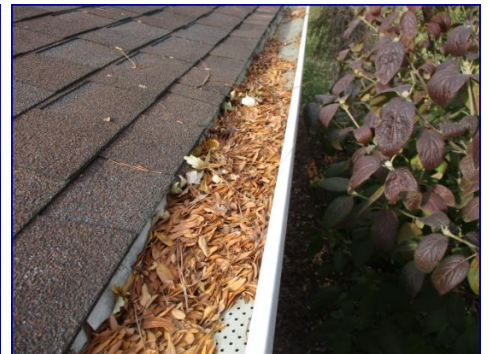
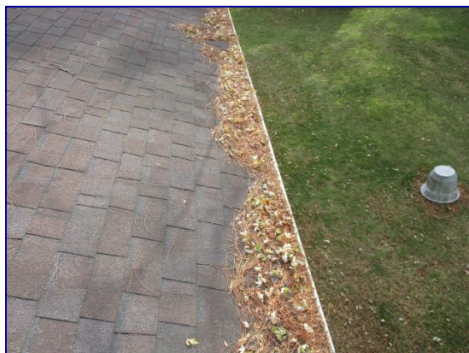
2. Gutters

- Downspouts needed

- The gutter downspouts don't direct water far enough away from the house. Recommend adding downspout extensions (5-6' extensions recommended) to discharge away from the home.
- Debris is blocking the water flow from the gutter system. Recommend cleaning the gutters to allow water to flow freely.

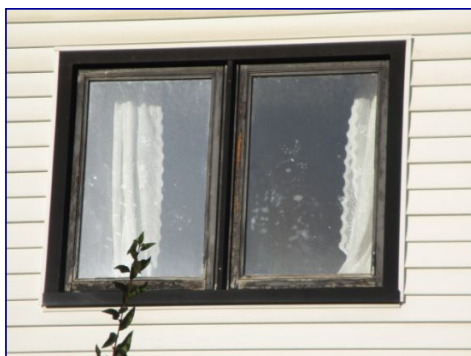
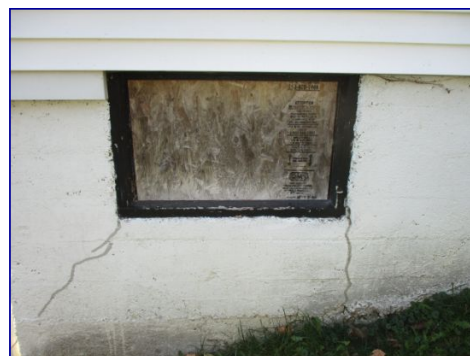
6. Windows/Screens

- Materials:
- Wood
- Observations:
- One or more exterior window frames have bare wood showing. Recommend a professional contractor paint to prevent additional damage.

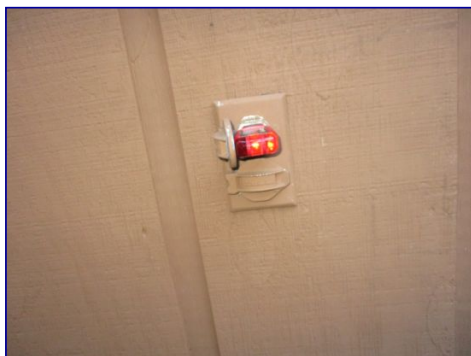
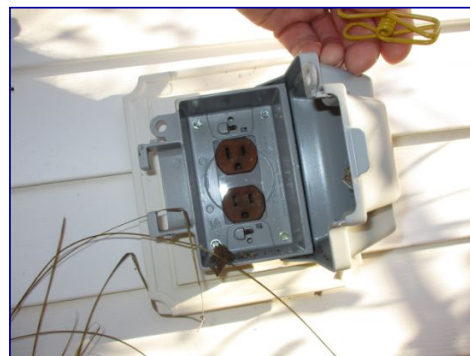
8. Exterior Receptacles

- Exterior receptacles: Yes
- Exterior receptacles, operable: Yes
- **GFCI** present: No
- Safety Hazard

- **GFCI receptacles are not installed at outdoor locations, which is a safety concern. Recommend a licensed electrician install GFCI receptacles.**

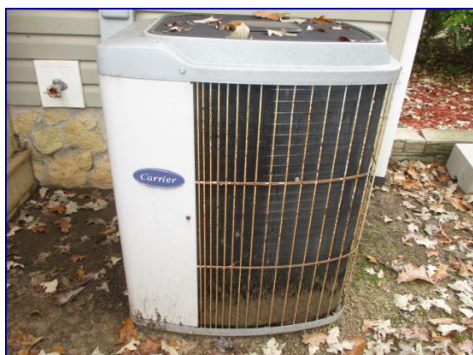
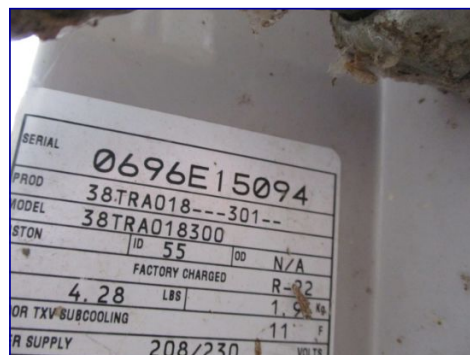
MFD: 1996 2.5-Ton

• Please note; the cooling system contains R-22 refrigerant (Freon). By EPA Standards, this Freon will be phased out starting in 2020. Accordingly, when the air conditioner requires repair to the "closed refrigerant system," the R-22 refrigerant may need to be removed. R-22 may be added to the system if available, or a retrofit option may be available. We recommend saving for repairs and replacement. Consult a licensed HVAC contractor as needed.

- **The AC unit is operating beyond its expected life span. (MFD 1996) Any extra time should be considered a bonus**

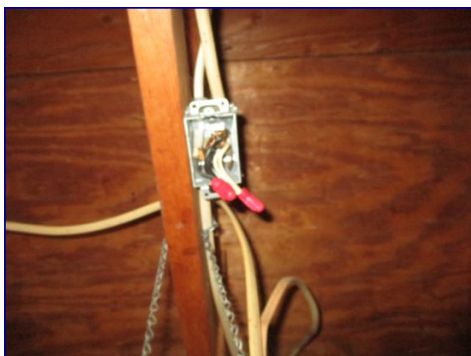
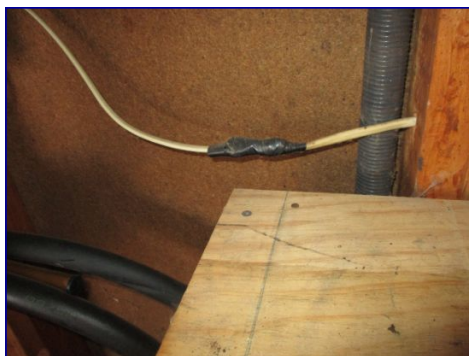
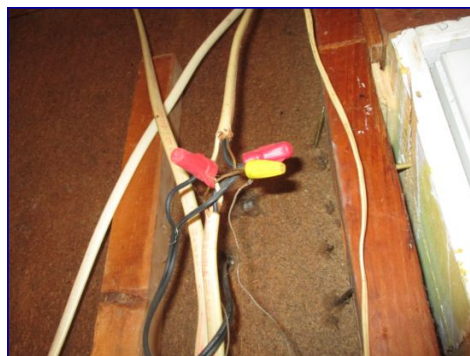
9. Electrical Receptacles

- Condition:
- Safety Hazard
- Observations:
- Open wiring and splices are present, which is a safety hazard. Repairs are needed by a qualified electrician.

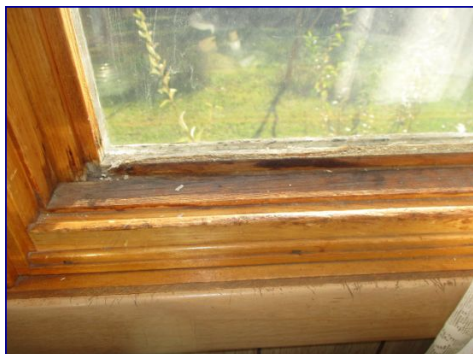
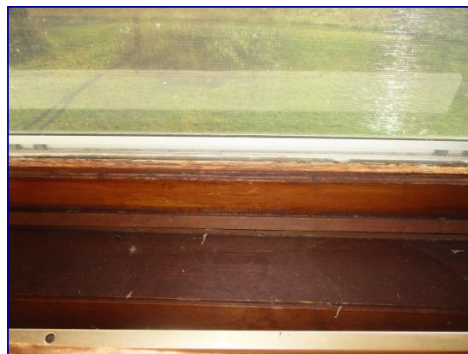
6. Windows

- Condition:
- Need resealing/painting
- Observations:

• All the windows in this home need to be painted or resealed. Recommend a qualified painting contractor make necessary repairs.

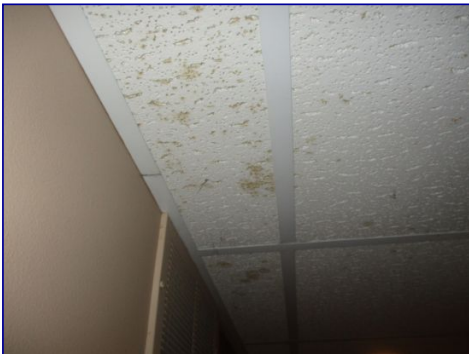
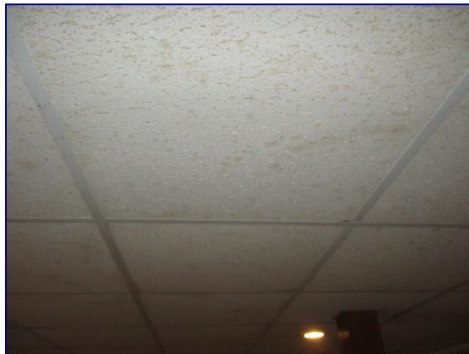
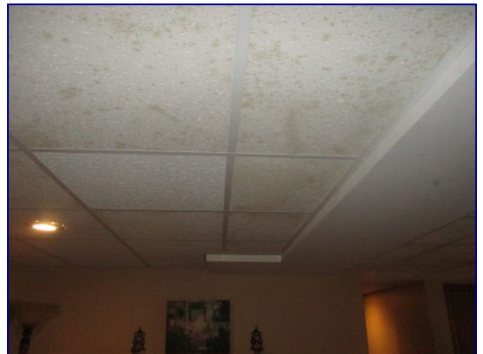
2. Walls & Ceiling

- Moisture stains on the ceiling

- There is staining on the room ceiling. There was no current moisture at the time of the inspection. This staining may be mold related. No testing was done to confirm this. It is just an observation. This is a common problem in homes that are not properly conditioned during high humidity/moisture times of the year. Further evaluation and repairs are needed by a qualified contractor.

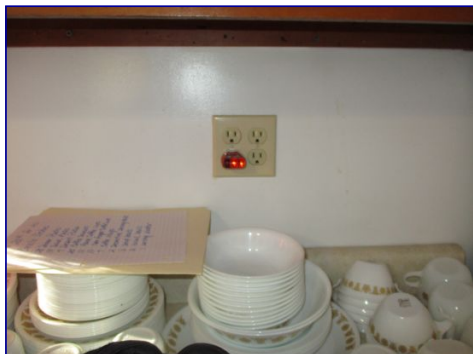
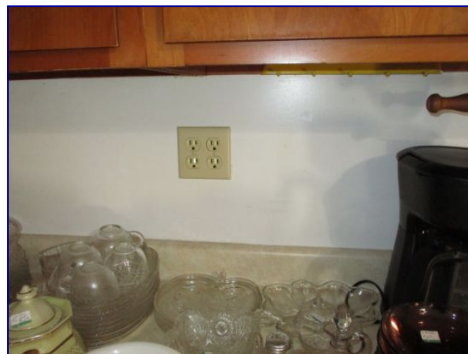
• GFCI receptacles are not installed within six feet of water in the kitchen. This is a safety concern. However, at the time the home was built, installing GFCI receptacles were not part of the standard building requirements. Recommend upgrading the GFCI receptacles to current standards for increased safety.

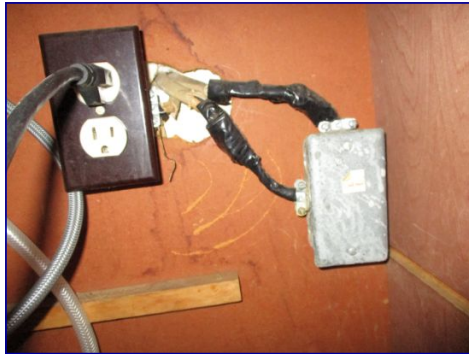
8. Kitchen Electrical

- There is open wiring/splices present in the sink base cabinet, which is a safety hazard. Repairs are needed by a qualified electrician.

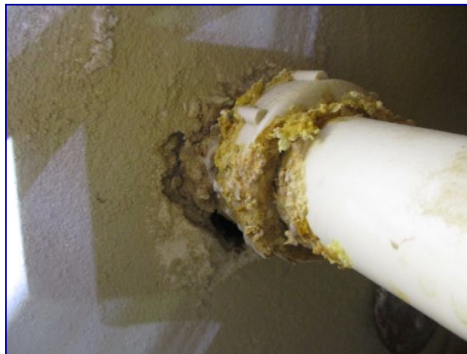
2. Sinks

- Pipes leak: Yes

- The drain is leaking in the bathroom 1. Recommend a licensed plumber repair or replace.

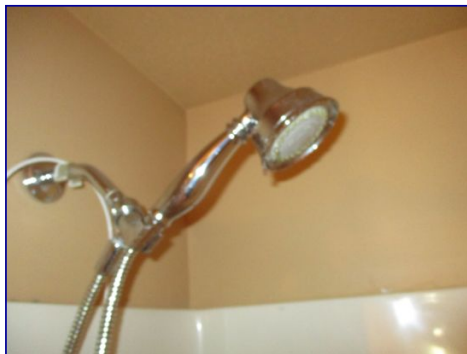
3. Showers

- Faucet leaks: Yes

- The showerhead is leaking. Recommend a licensed plumber replace as needed.

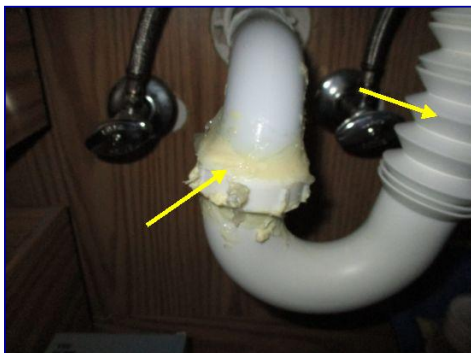
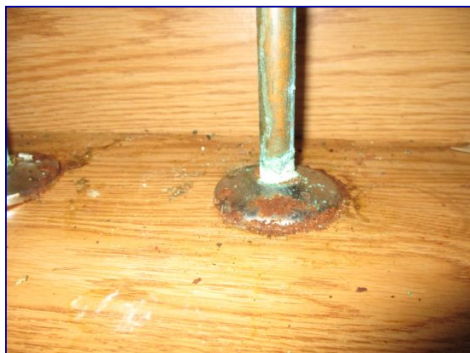
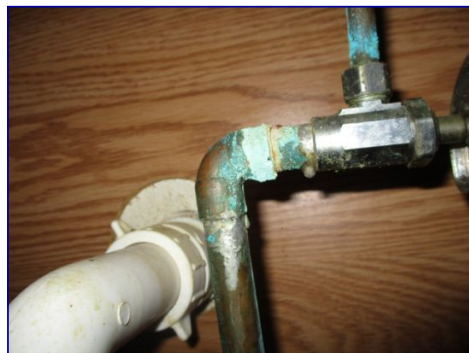
2. Sinks

- Pipes leak: Yes
- Observations:
- Flex tubing is being used as part of the drain system in the bathroom 2, which is a nonprofessional installation of drain piping. The trap connection is caulked, which is also a temporary repair. Recommend a licensed plumber repair.
 - Pipes are leaking in the bathroom 2. Recommend repair or replacement by a licensed plumber.

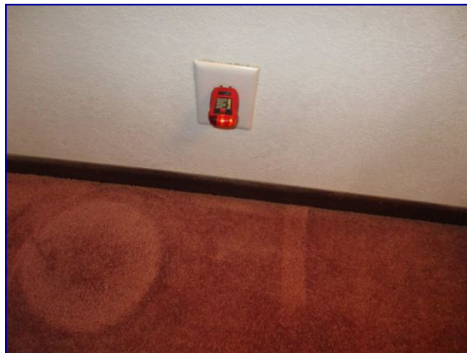
4. Receptacles

- GFCI receptacles are not installed within six feet of water in bathroom 3, which is a safety concern. However, at the time the home was built, installing GFCI receptacles were not part of the standard building requirements. Recommend upgrading the GFCI receptacles to current standards for increased safety.

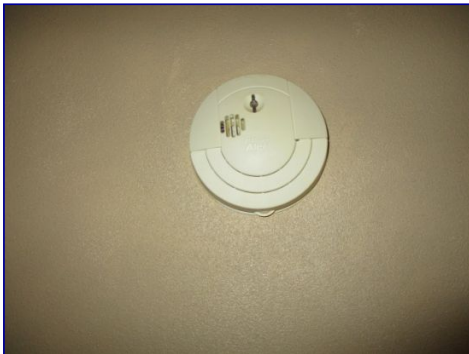
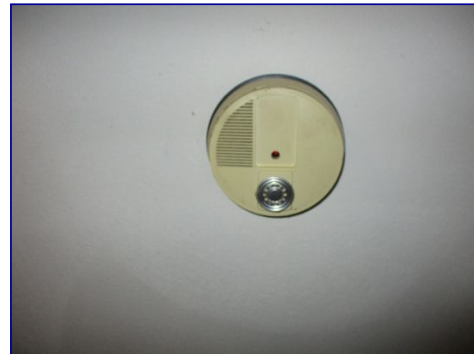
1. Smoke/Carbon Monoxide Detectors

- - Smoke detectors that are over 10 years old are considered to unreliable and past their expected service life. Based on the age of this home and the appearance of the smoke detector(s), it is likely that they are older than 10 years old and replacement is recommended.
- SAFETY - The home currently has at least one carbon monoxide detector. Additional carbon monoxide detectors are recommended in each bedroom. Carbon monoxide is a colorless, odorless gas that can lead to poisoning and death. Carbon monoxide can enter a home several ways such as from automobiles in the garage or a malfunctioning furnace.
- SAFETY - The home is equipped with smoke detectors. However, for added safety, I recommend additional smoke detectors in the bedrooms.

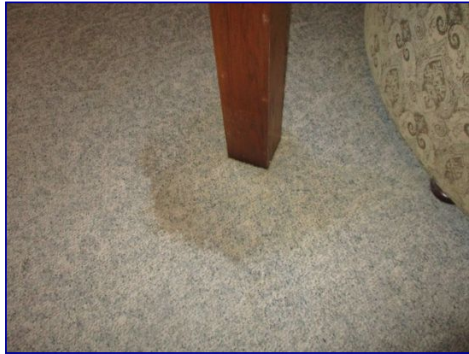
2. Basement Floor

- There was previous moisture staining in one or more areas as seen at the basement floor. No current moisture was detected. Recommend monitoring and consulting a licensed contractor as needed.

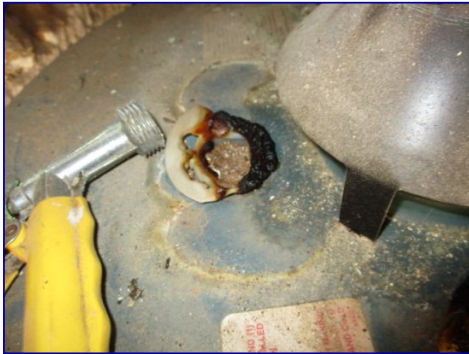
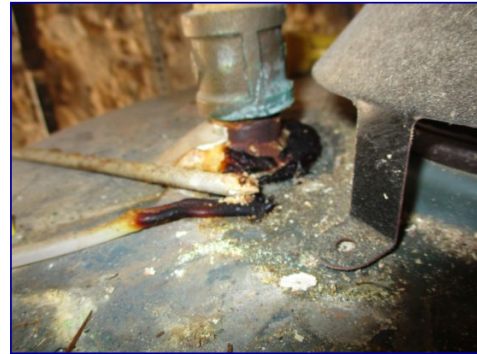
4. Combustion Air Venting Present

- Combustion Venting:
- No
- Observations:
- The water heater combustion venting is back-drafting, which is a safety hazard. Recommend a licensed plumber repair before closing.

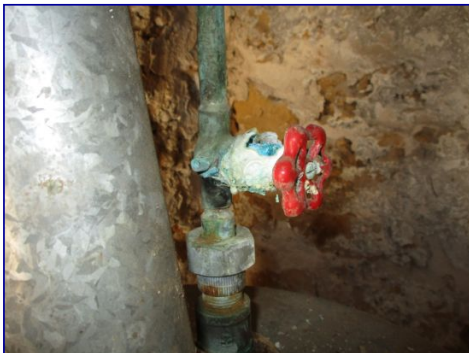
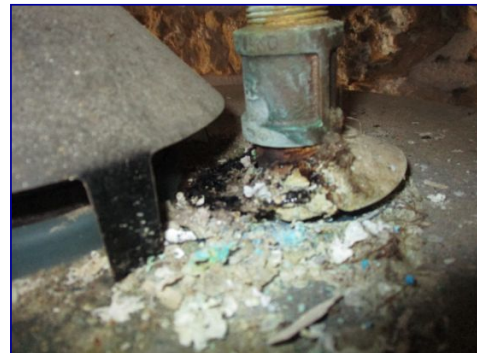
6. Comments

- There are corroded pipes at the water heater. Recommend a licensed plumber repair.

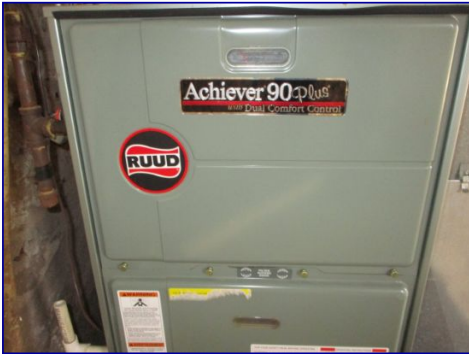
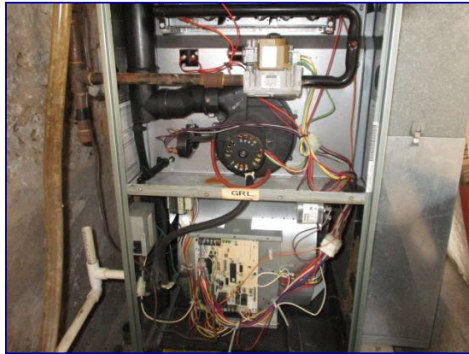
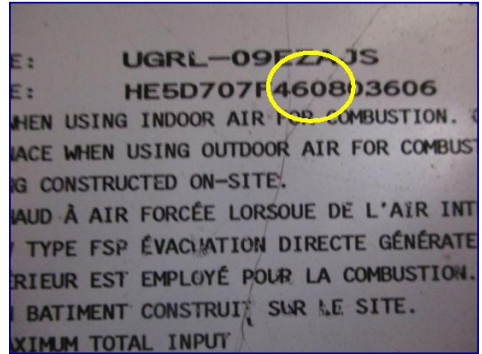
MFD 2008 46th week

- Furnace Age: The furnace is in the third quarter of its expected life span. MFD 2008

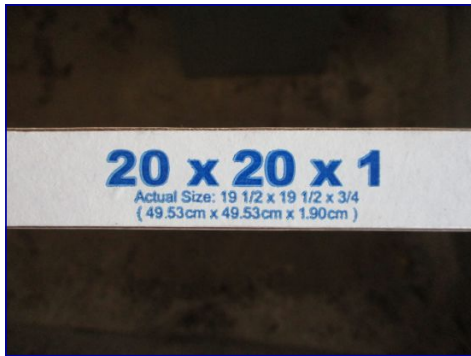
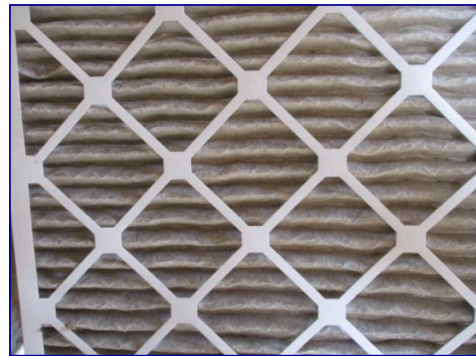
2. Filter

- Needs cleaning/replacement

- The furnace filter is dirty. Recommend changing the filter per the manufacturer's recommendations.
